IN DEPTH INSPECTION REPORT

P.I.N. 3501.60

B.I.N. 1093562

TEAM LEADER	Logan Bessel, P.E.	98781
		NYSPE LICENSE #
ASSISTANT TEAM LEADER	Samantha Lusher	
ASSISTANT TEAM LEADER		
ASSISTANT TEAM LEADER		
FEATURE CARRIED	I-481 Northbound	
FEATURE CROSSED	Manlius Center Road (NYS Route 290)	
DATE FIELD WORK BEGAN	February 7, 2022	
DATE FIELD WORK COMPLETED	February 9, 2022

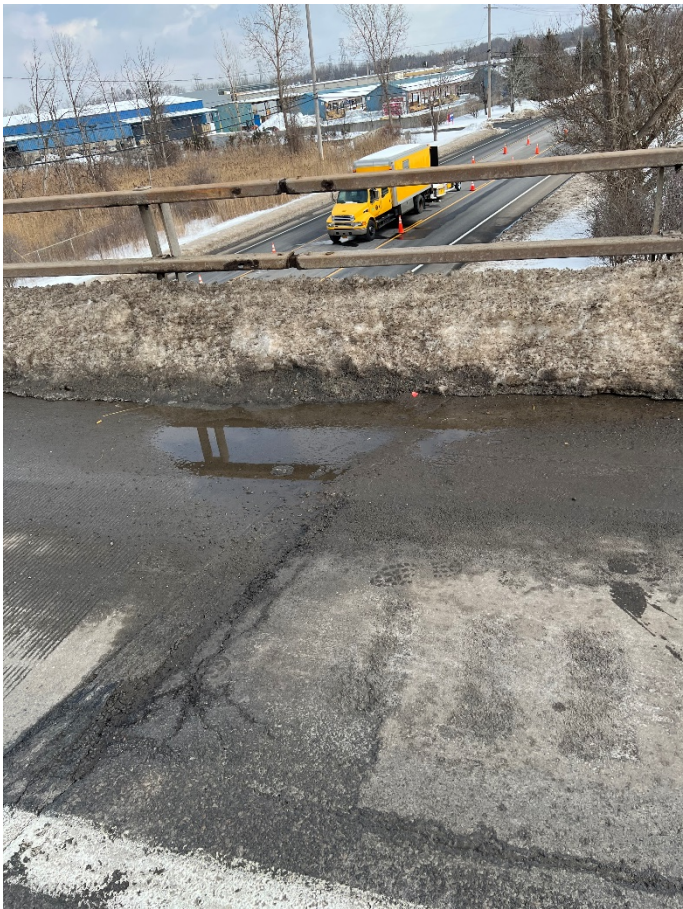
PHOTO 33

DESCRIPTION: BEGIN BRIDGE DECK JOINT RIGHT SHOULDER – PUDDLING

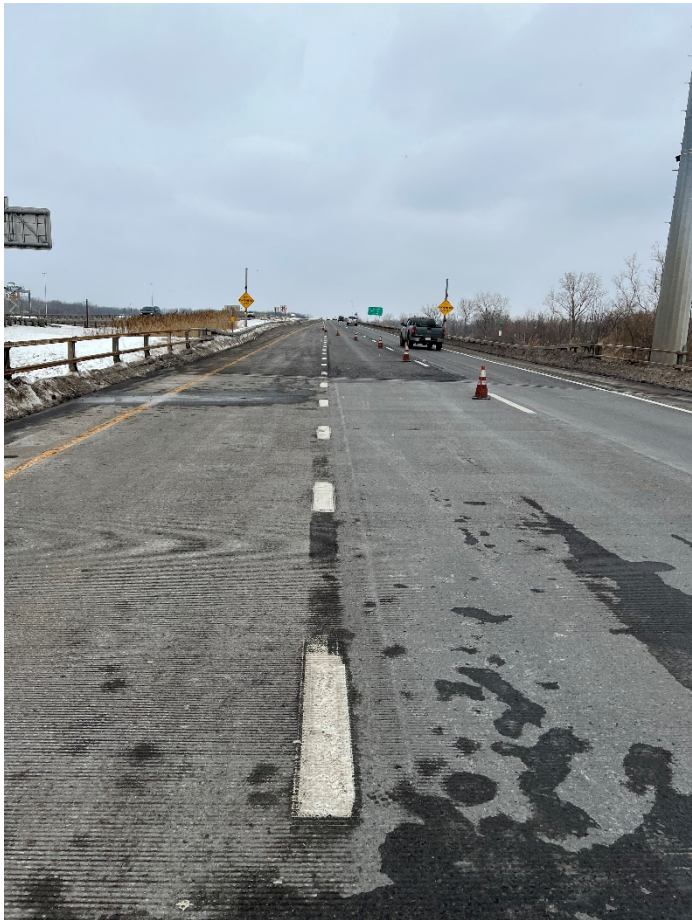
PHOTO 34

DESCRIPTION: BRIDGE DECK GENERAL VIEW – LEFT TRAVEL LANE – AGGREGATE IN GOOD CONDITION , MIDDLE TRAVEL LANE – AGGREGATE WORN

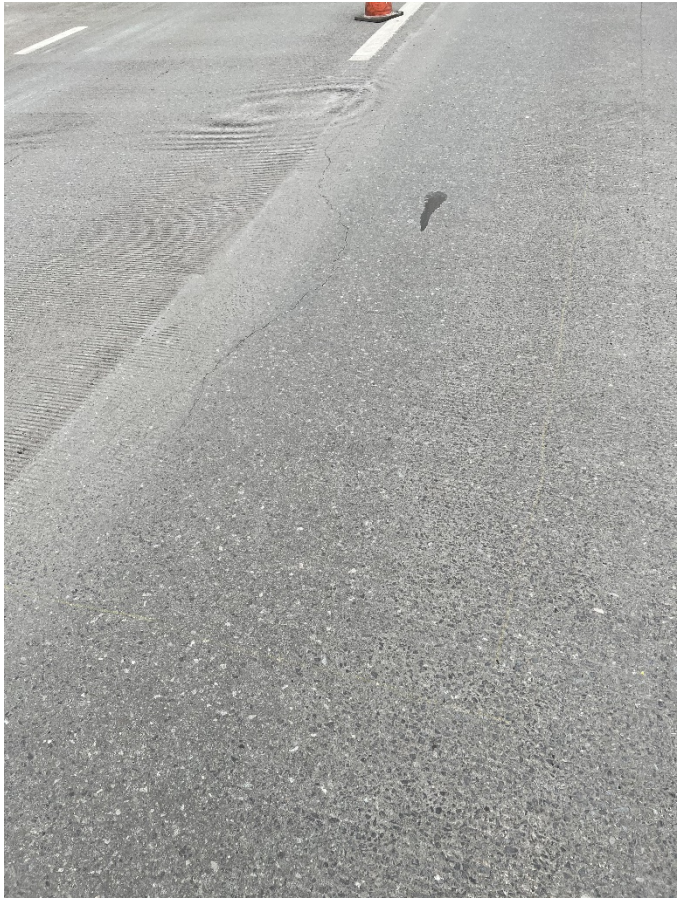
PHOTO 35

DESCRIPTION: BRIDGE DECK – RIGHT TRAVEL LANE
AGGREGATE COMPLETELY POLISHED
, CRACKING

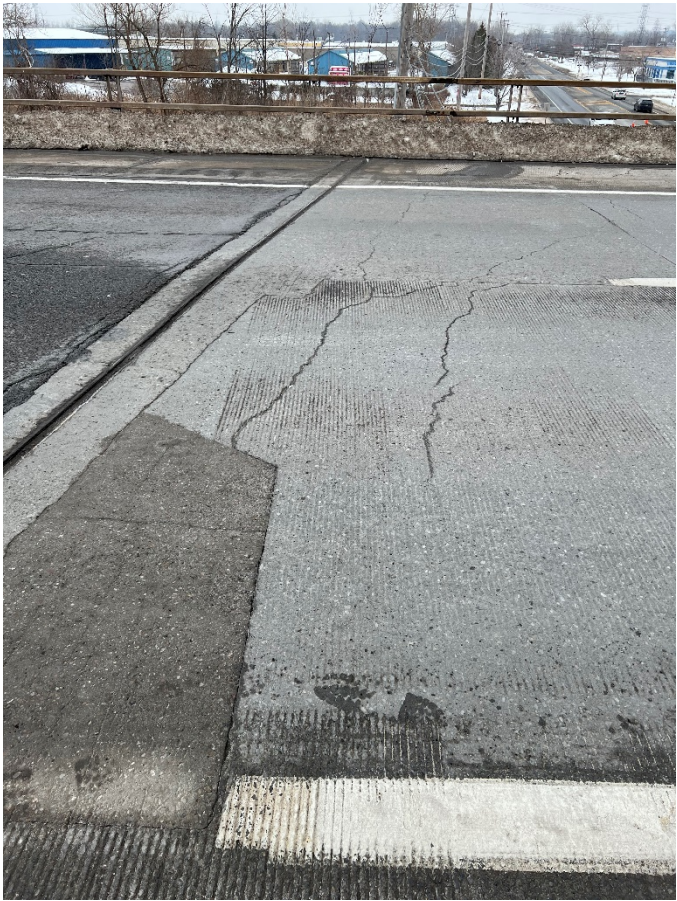
PHOTO 36

DESCRIPTION: CENTER LANE – END BRIDGE JOINT –
CRACKING THROUGH TRAVEL LANES
TO RIGHT SHOULDER

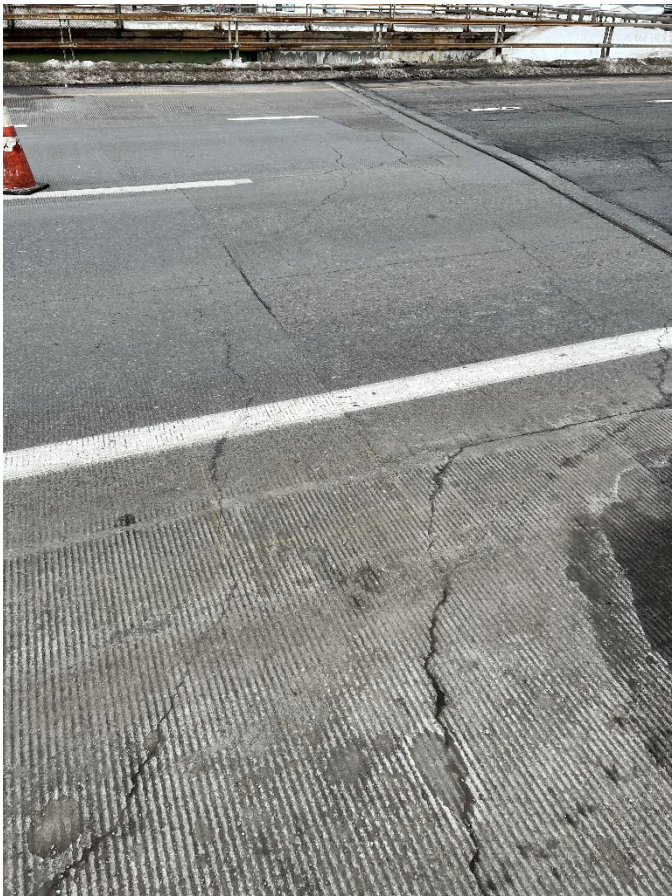
PHOTO 37

DESCRIPTION: RIGHT SHOULDER – END BRIDGE JOINT
– CRACKING FROM CENTER LANE TO
RIGHT SHOULDER

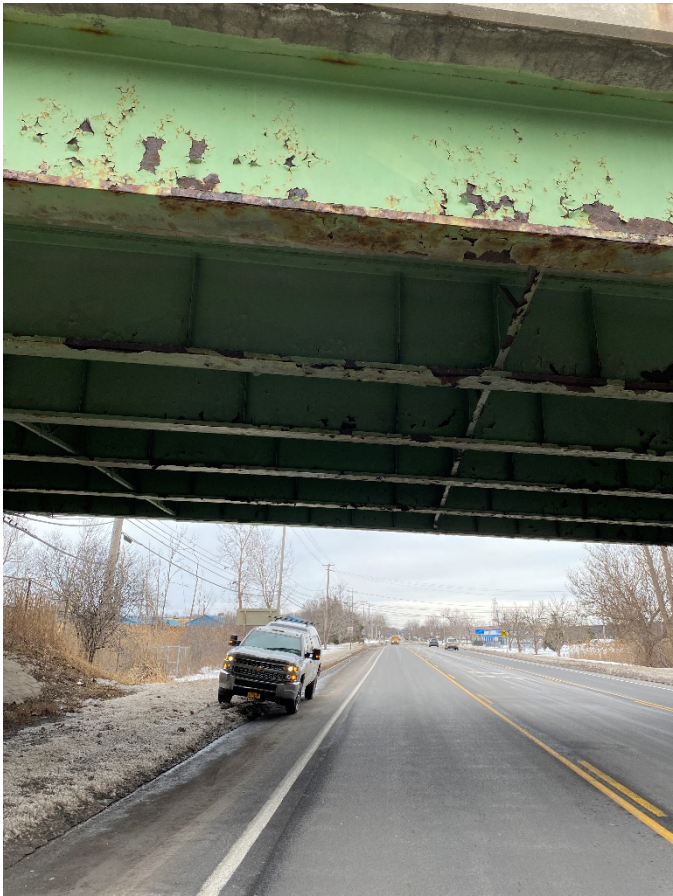
PHOTO 38

The steel showed signs of deterioration. The paint system is failing over 75% of the structure and bare steel was exposed. The fascia girders appeared to be in the worst condition with section loss in the web and bottom flanges throughout the length of the girders. All of the girders exhibited impact damage to the bottom flange over the NYS 290 Westbound lane. The damage includes dents and scrapes to the bottom flange.

DESCRIPTION: END SPAN – LEFT FASCIA – IMPACT
DAMAGE LINE – BOTTOM FLANGES
